# Hollywood Branch Stream Restoration Project

**Montgomery County  
Department of Environmental Protection**

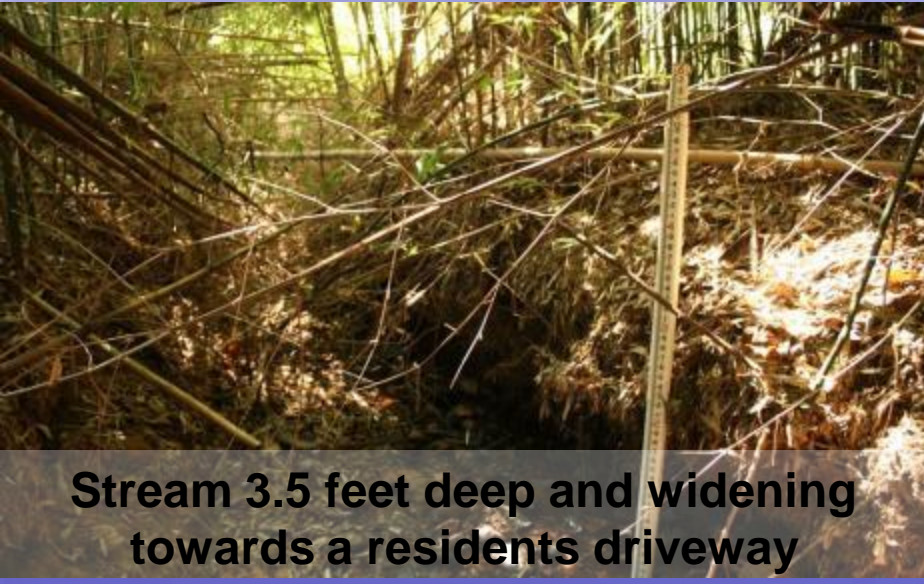
**Stream 3.5 feet deep and widening towards a residents driveway**

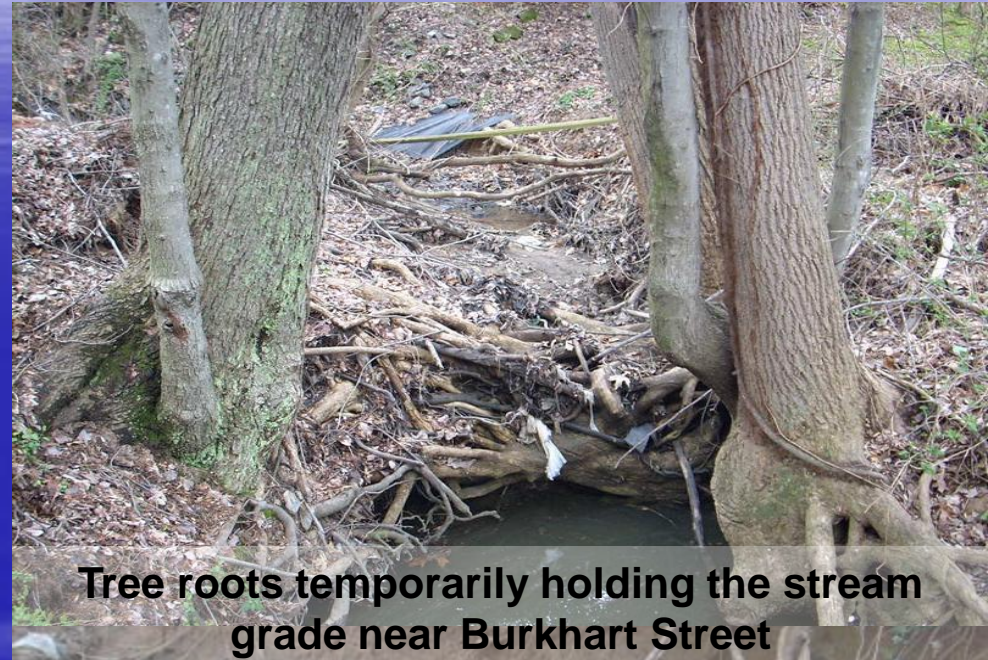
**Tree roots temporarily holding the stream grade near Burkhart Street**

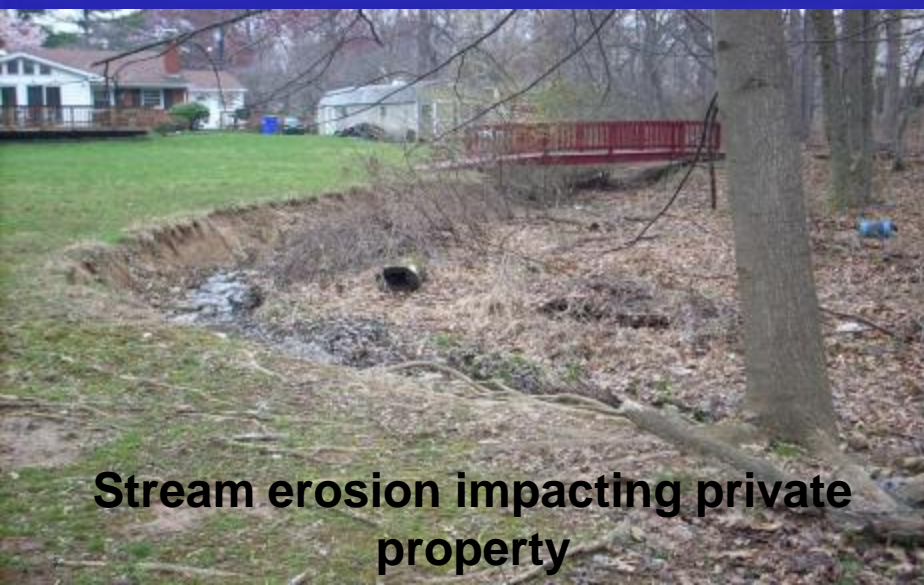
**Stream erosion impacting private property**

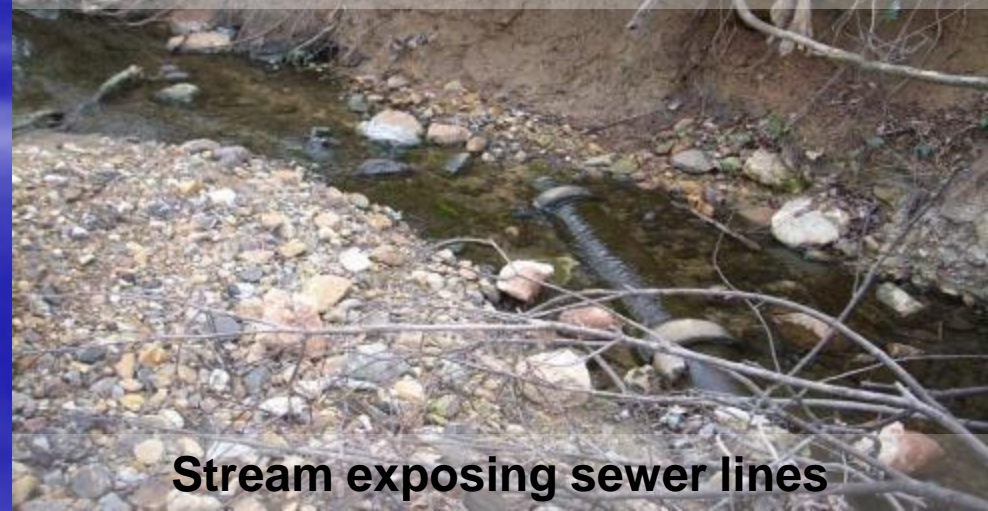
**Stream exposing sewer lines**
